LOW FRICTION HULL COATINGS
FOR ICEBREAKERS

PHASE III TECHNICAL REPORT

S.J. Calabrese and F.F. Ling
Department of Mechanical Engineering,
Aeronautical Engineering & Mechanics
Rensselaer Polytechnic Institute

U.S. DEPARTMENT OF TRANSPORTATION
United States Coast Guard
Office of Research and Development
Washington, D.C. 20590

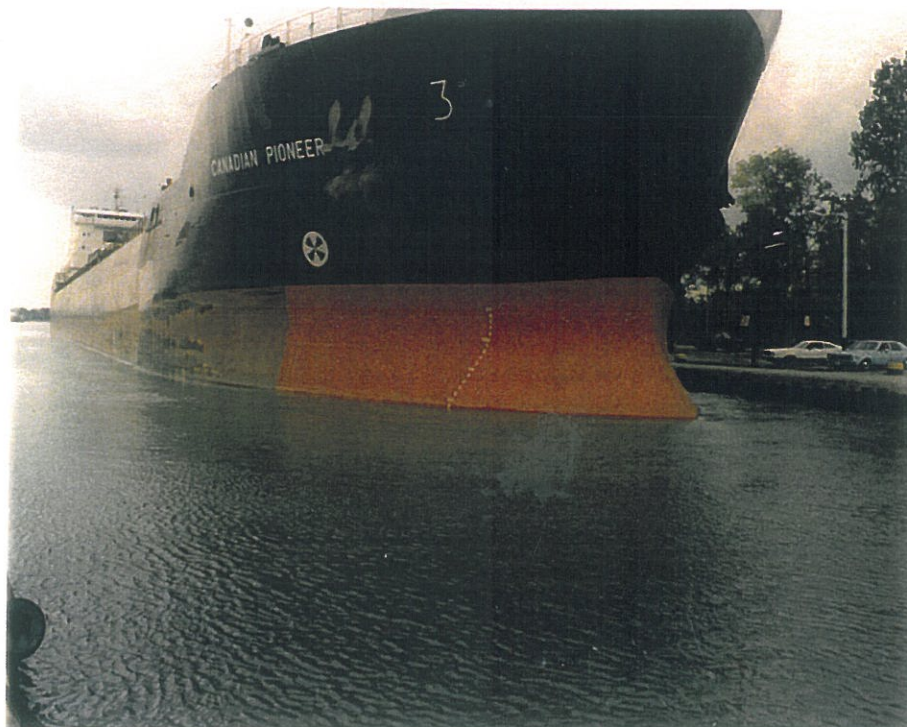
Zebtron Bow -
Excellent condition.

Five Coat Epoxy System -
Completely removed.

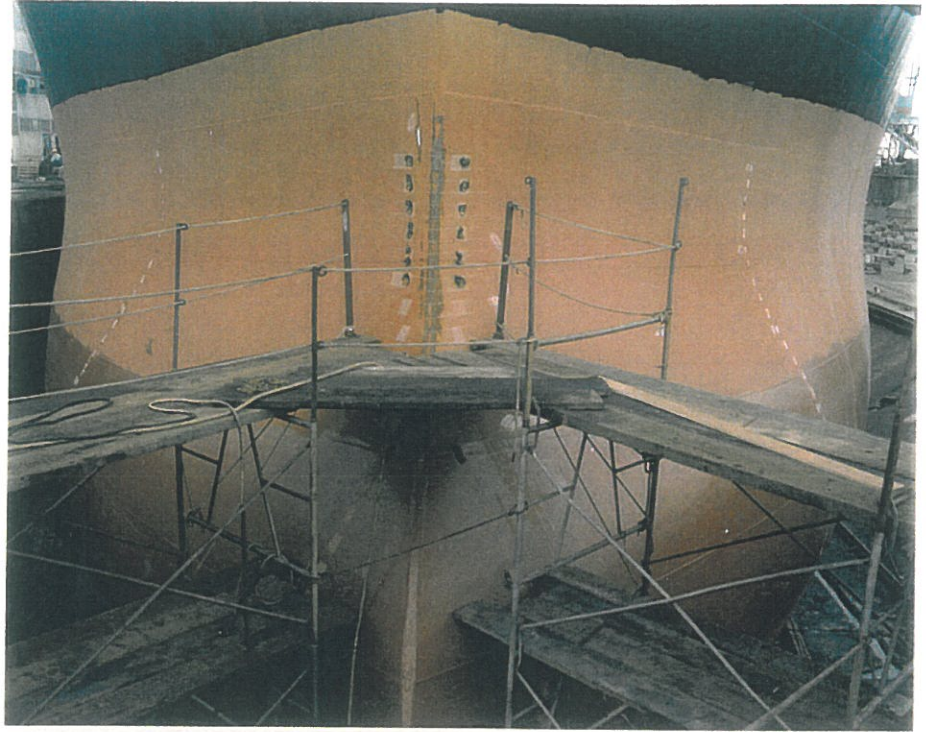
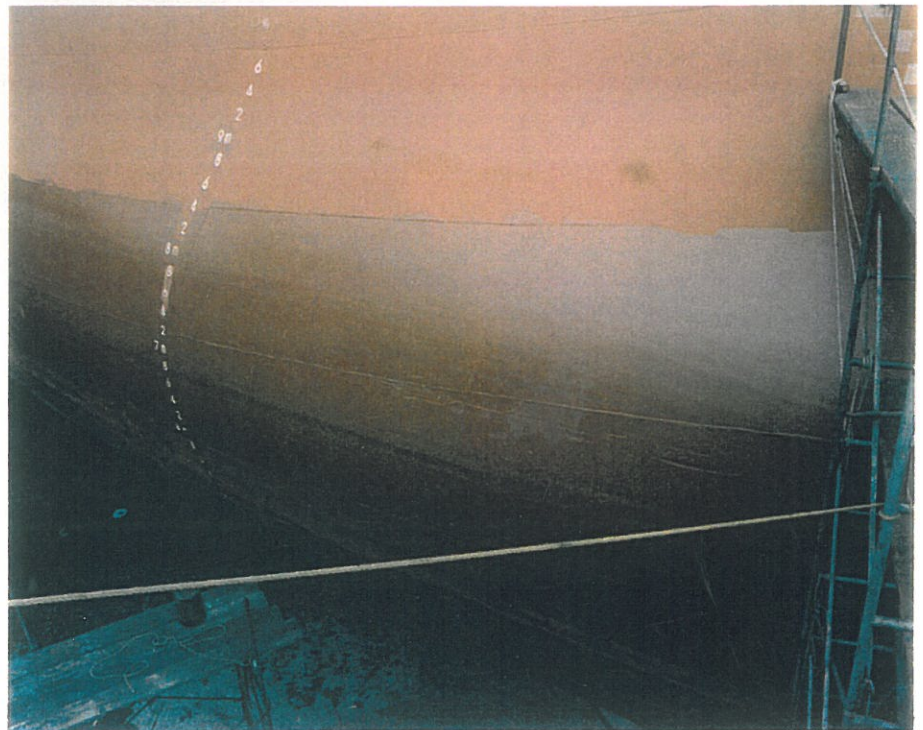
4. & 5.

Two years service.

1984 Docking.

Limited damage to coating
where ship touched bottom.
Coating did not peel and
resisted the extreme
abrasion.

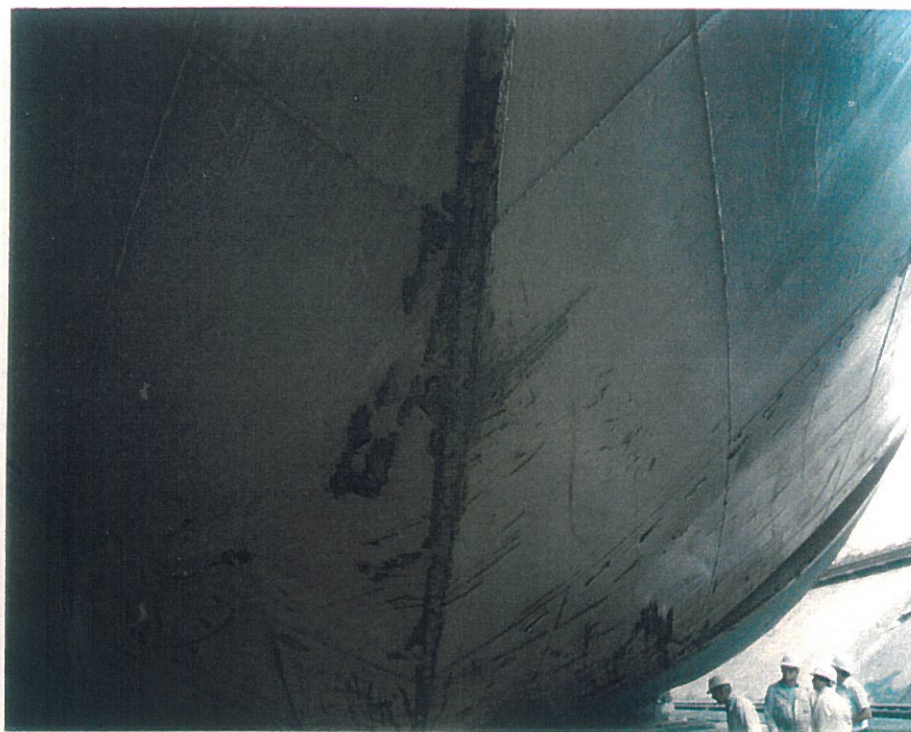
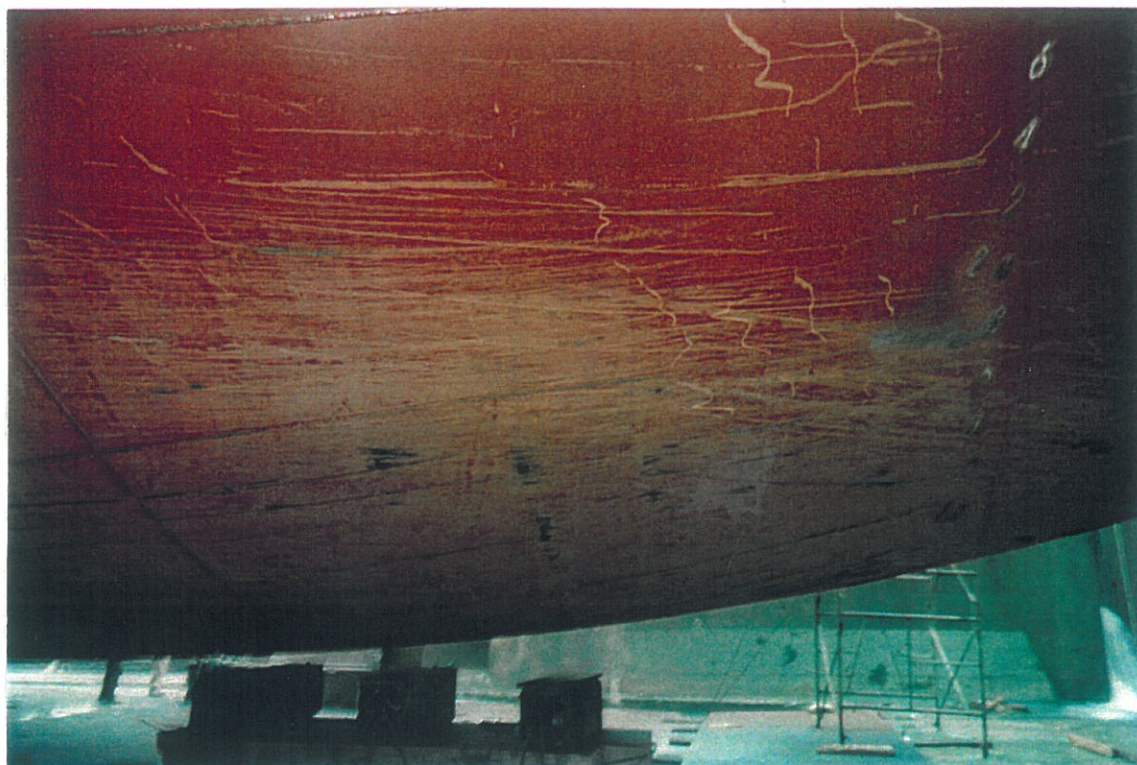
6. & 7.

Two years service

1984 Docking.

Stern coating undamaged.

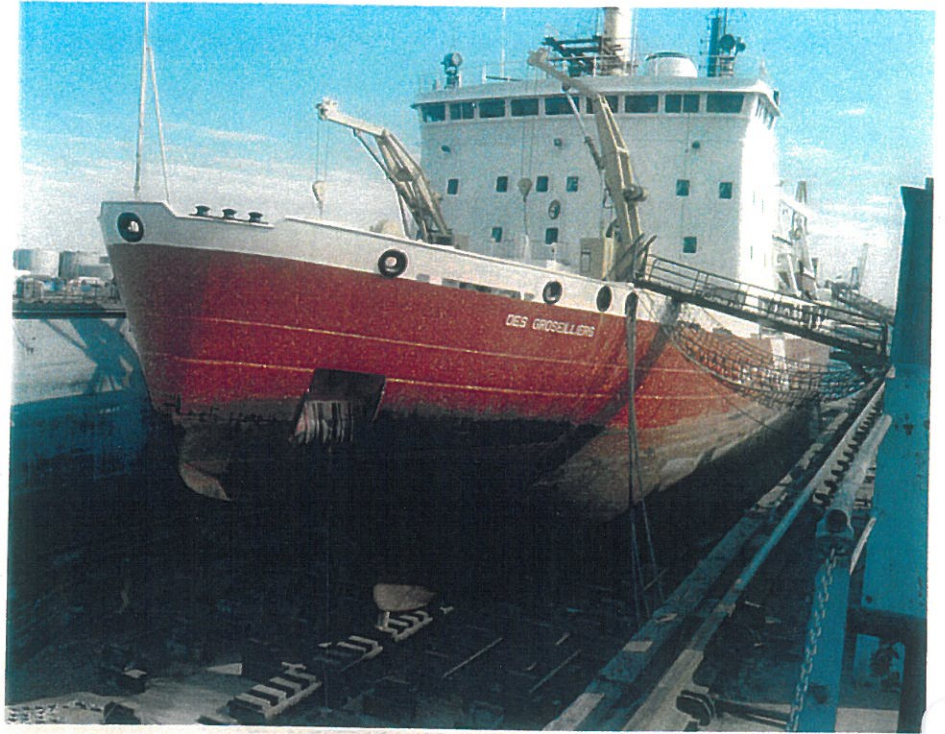
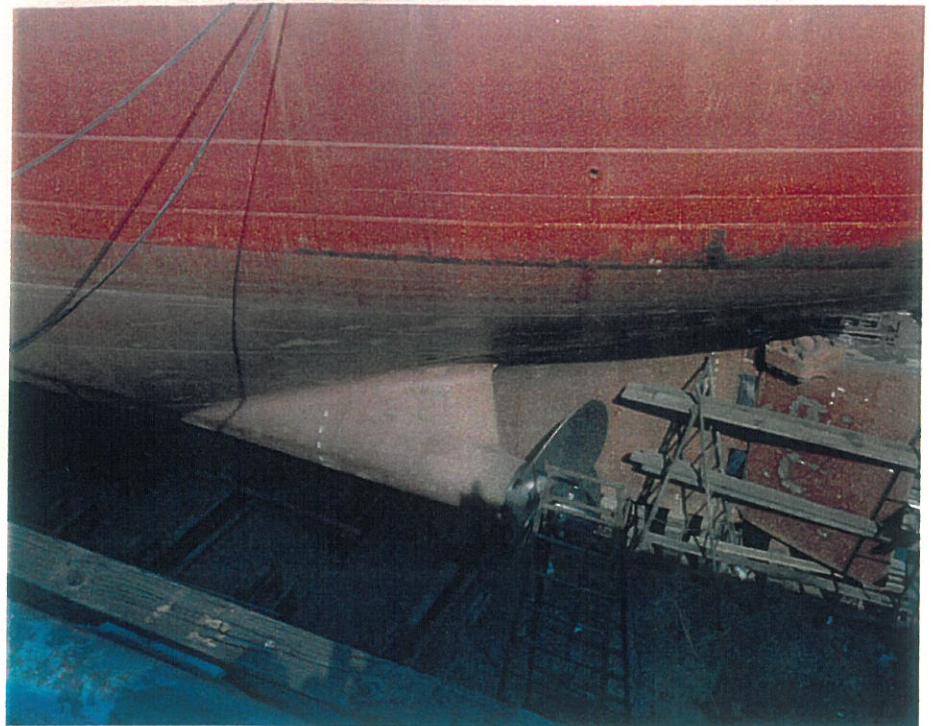
9. & 10.

3 years service breaking
up to 5 meter thick ice.

1985 Docking:
Versatile Vickers
Shipyard, Montreal.

Port side:
Max. loss due to ice
damage - 10%

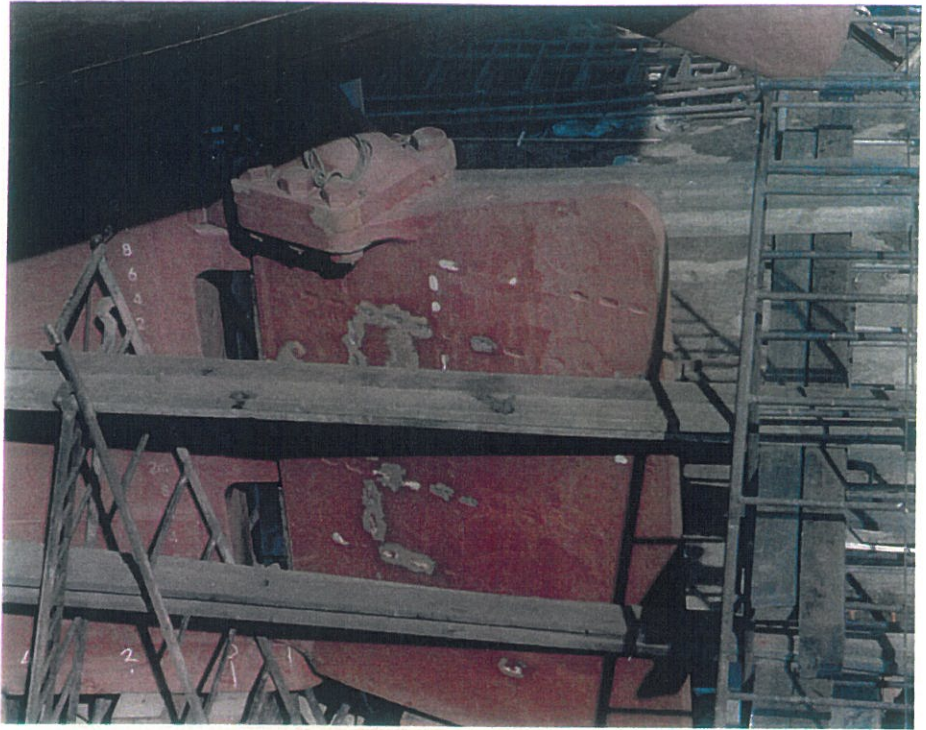
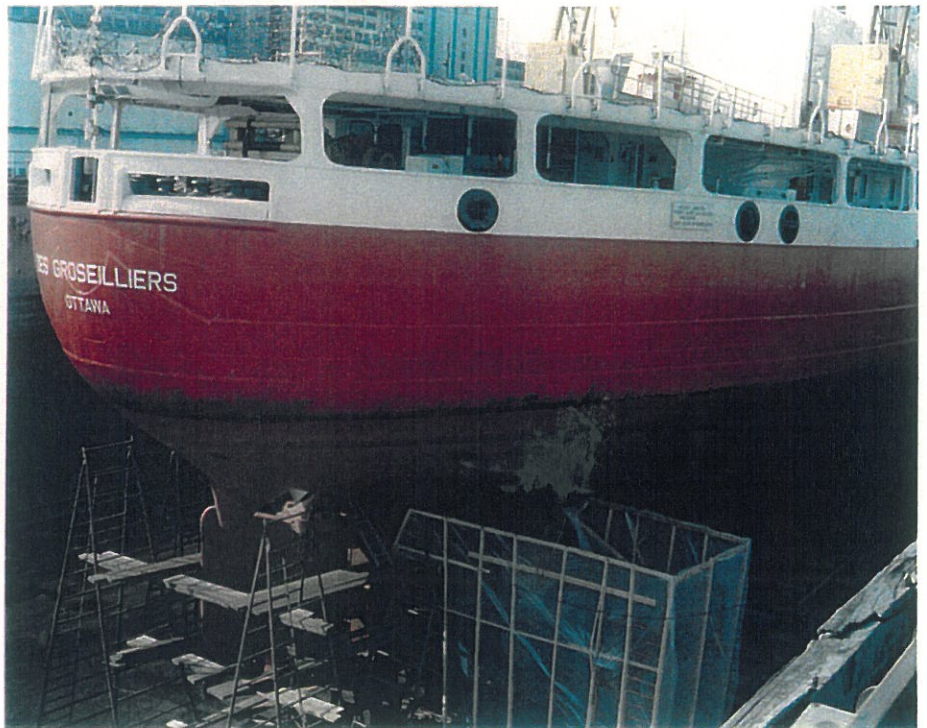
11. & 12.

Stern:
Coating virtually
undamaged.

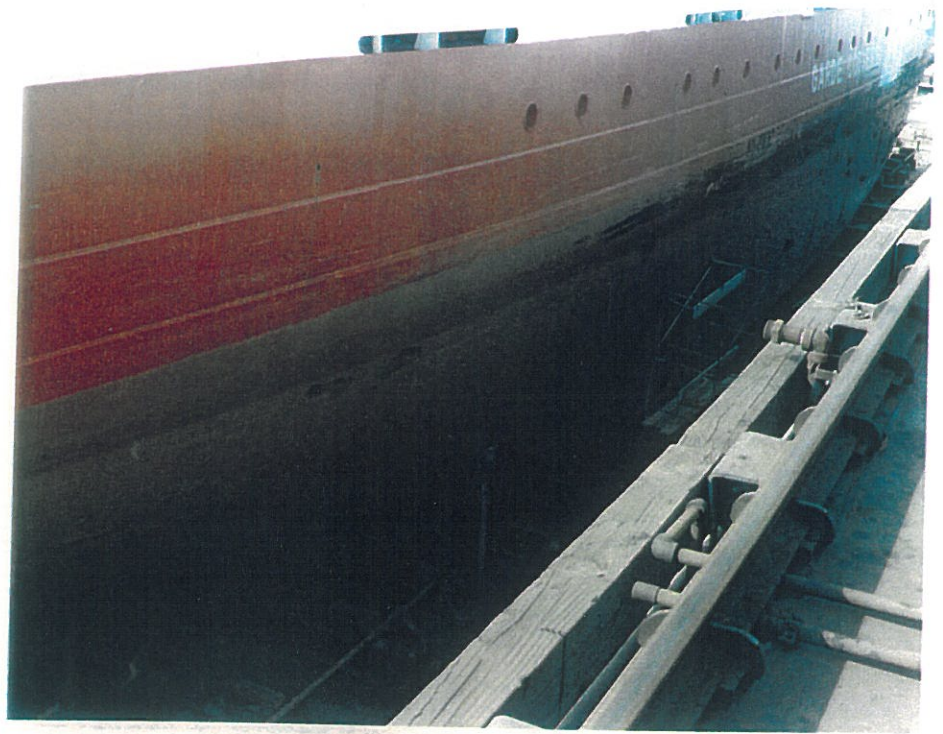
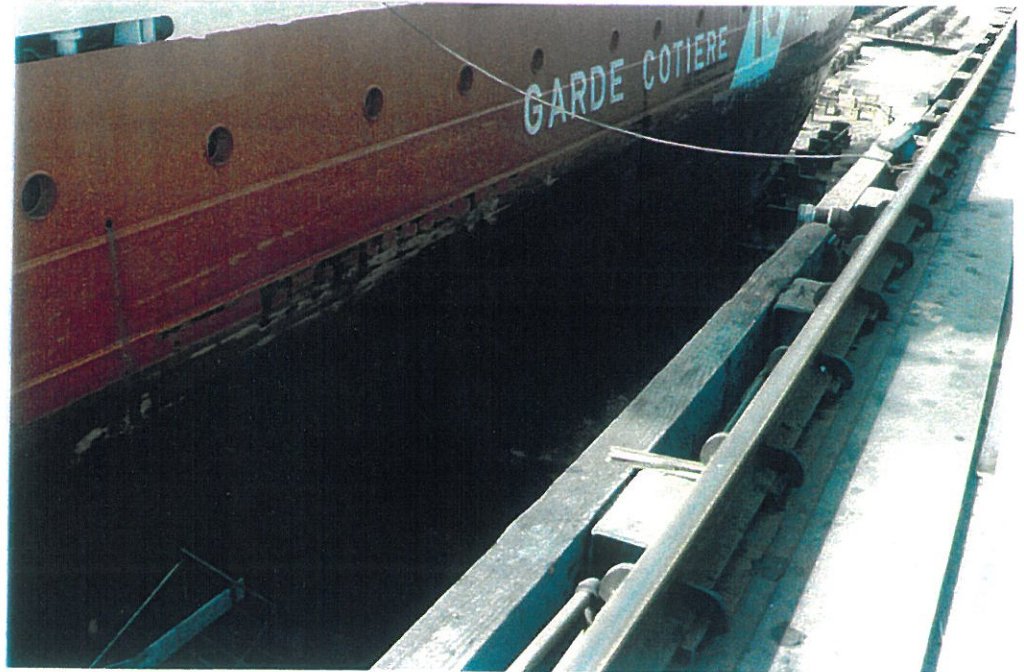
13. & 14.

Starboard side:
Max. loss due to ice
damage : 10%

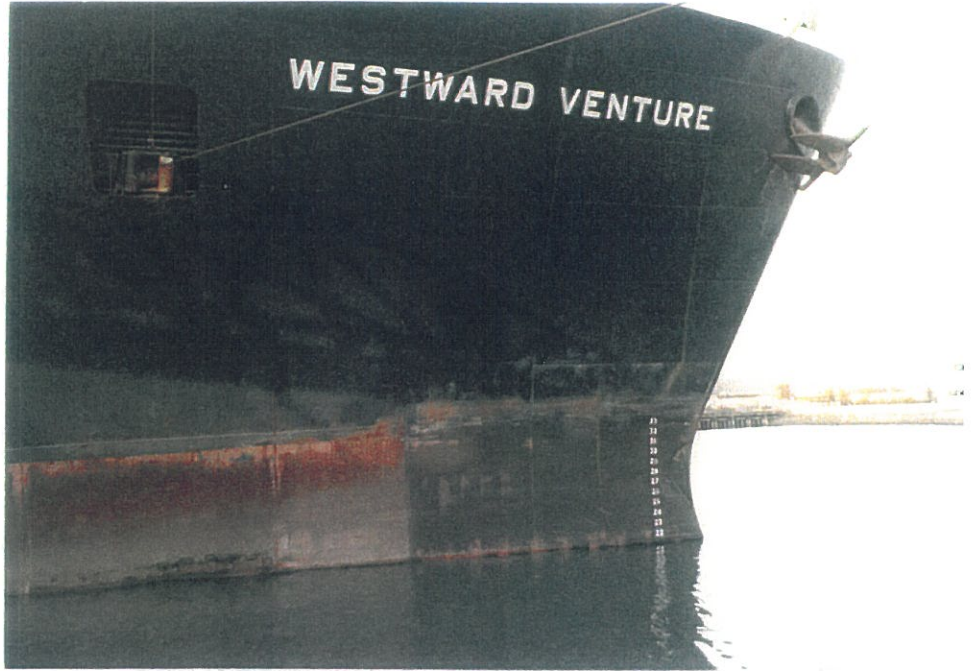
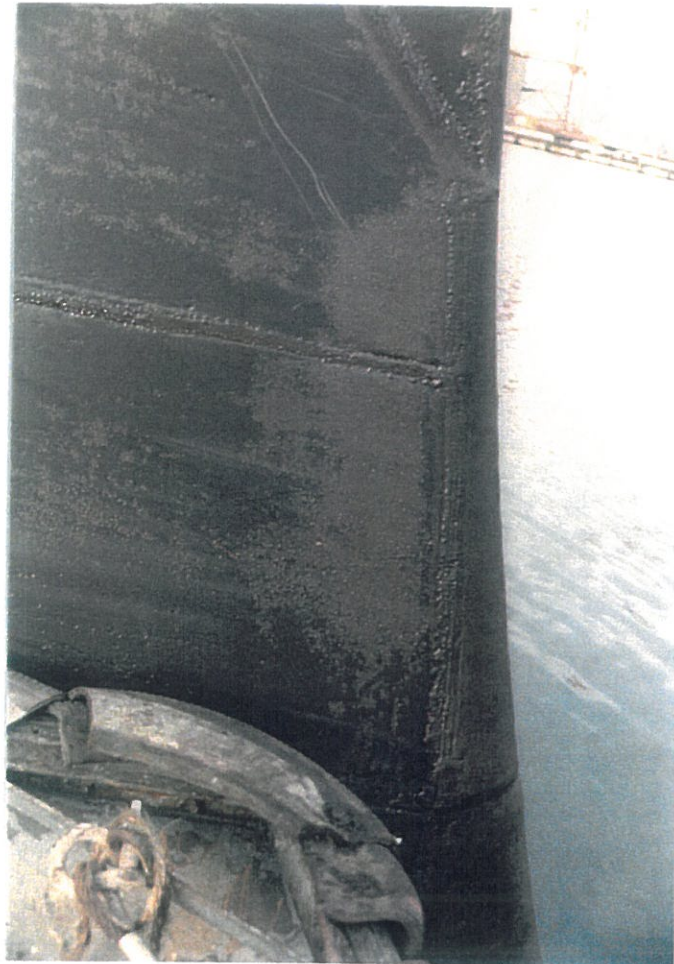
16. & 17.

After one year service
the epoxy is worn through
in several locations.

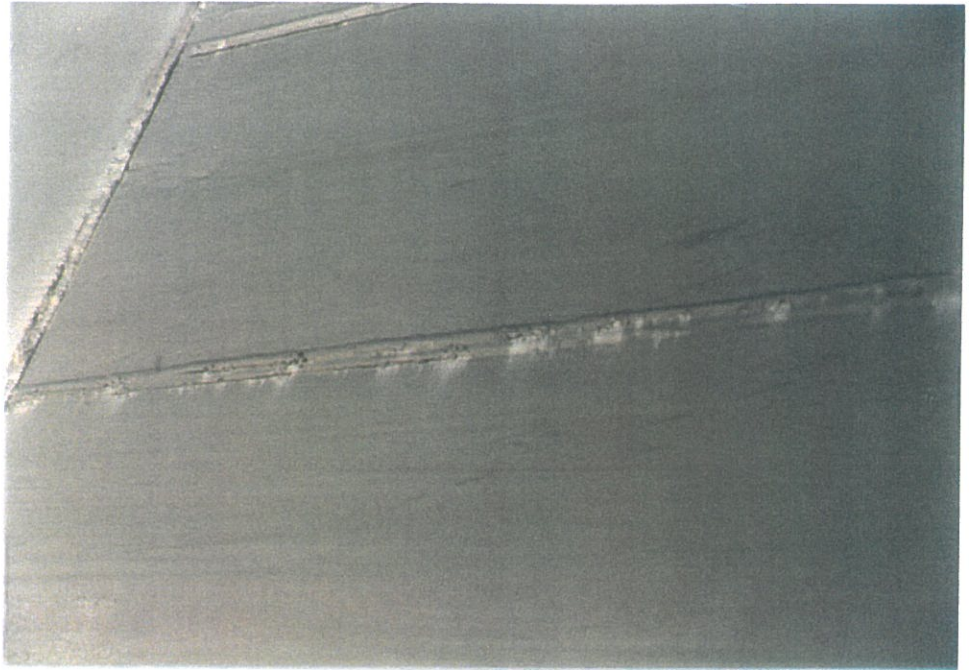
18.

One year service:

Weld corrosion
evident on epoxy.

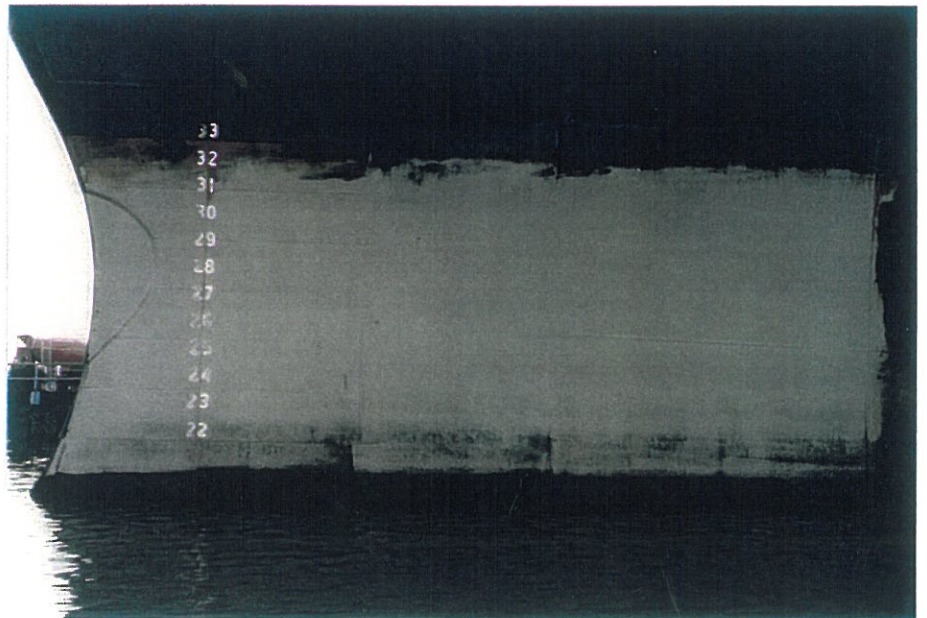
One year service:

Zebtron in excellent
condition.
Slight wear at raised
weld only.

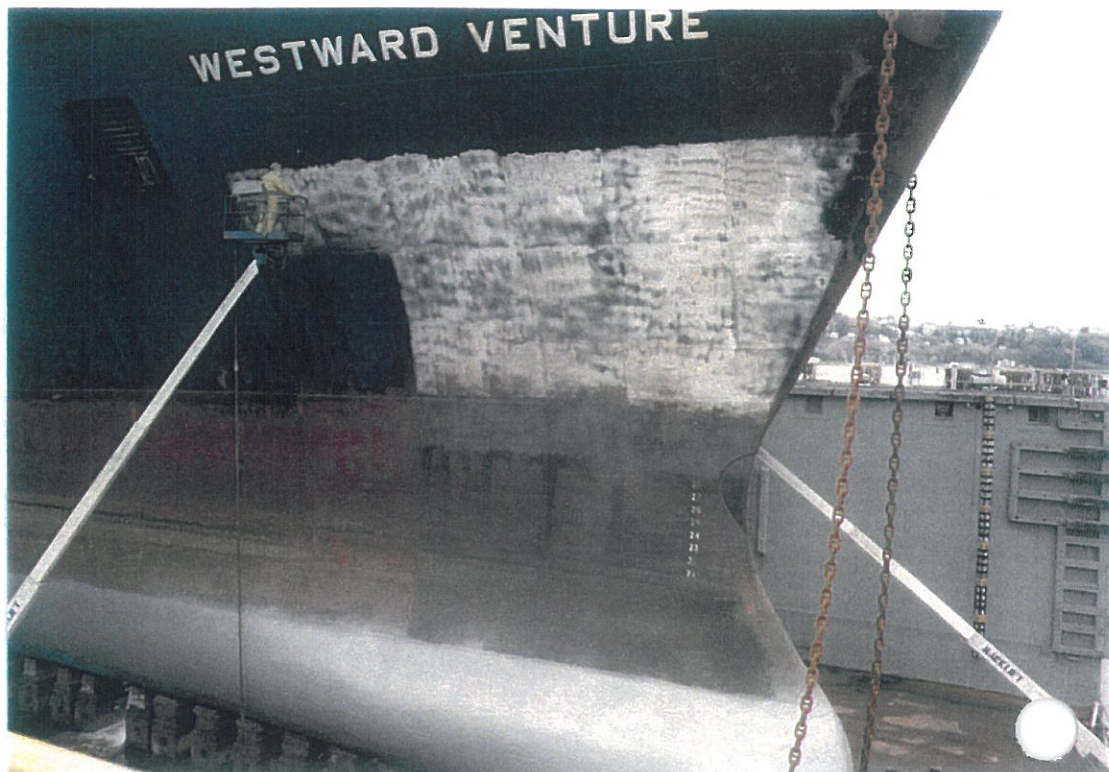
20.

Two year service:

Epoxy completely
removed.

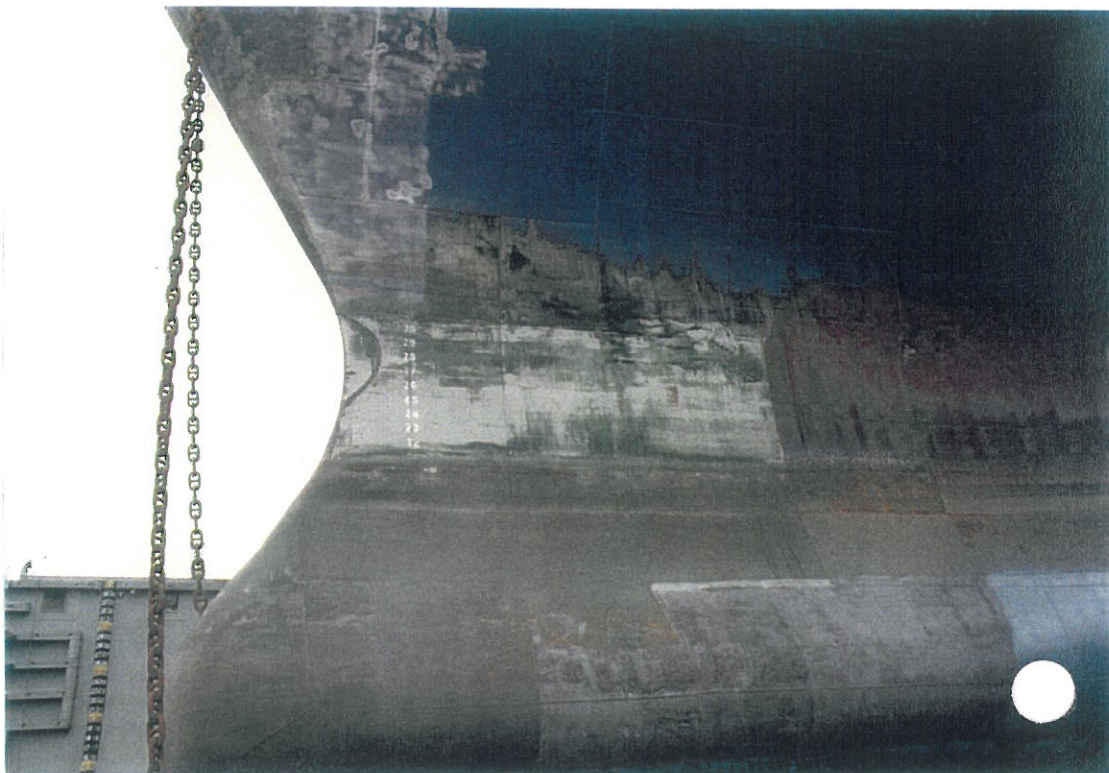
21. & 22.

Two years service.

Zebtron in excellent
condition could not be
grit blasted from
surface without great
difficulty.

Max. extent of fouling.

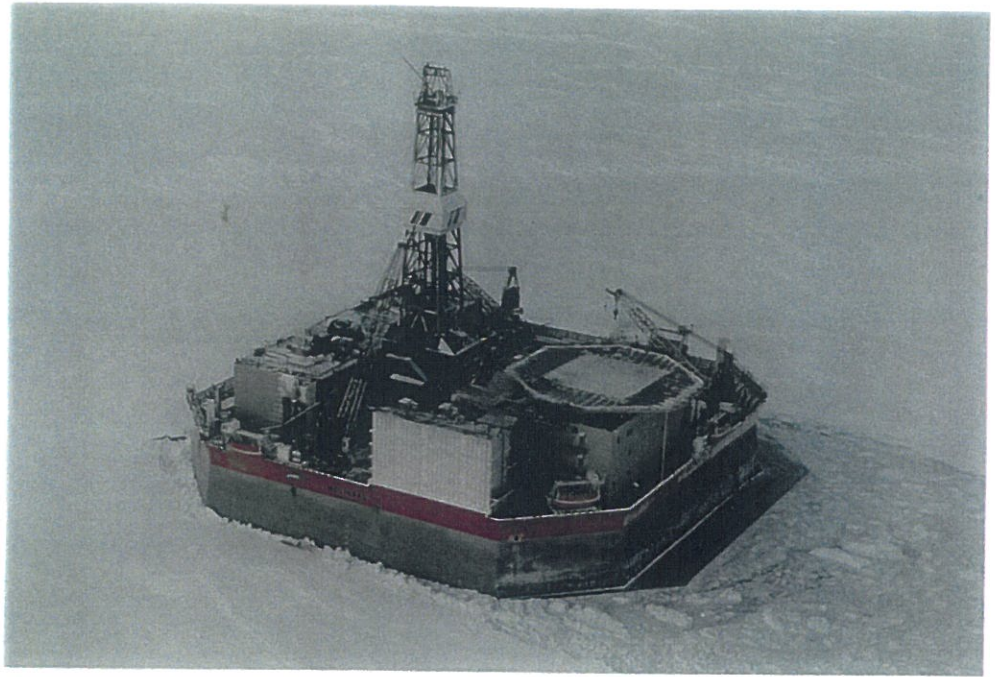
29.

Coating performance in Beaufort Sea during second ice season.
